DCB TLS Version Change Issues

4/11/2022

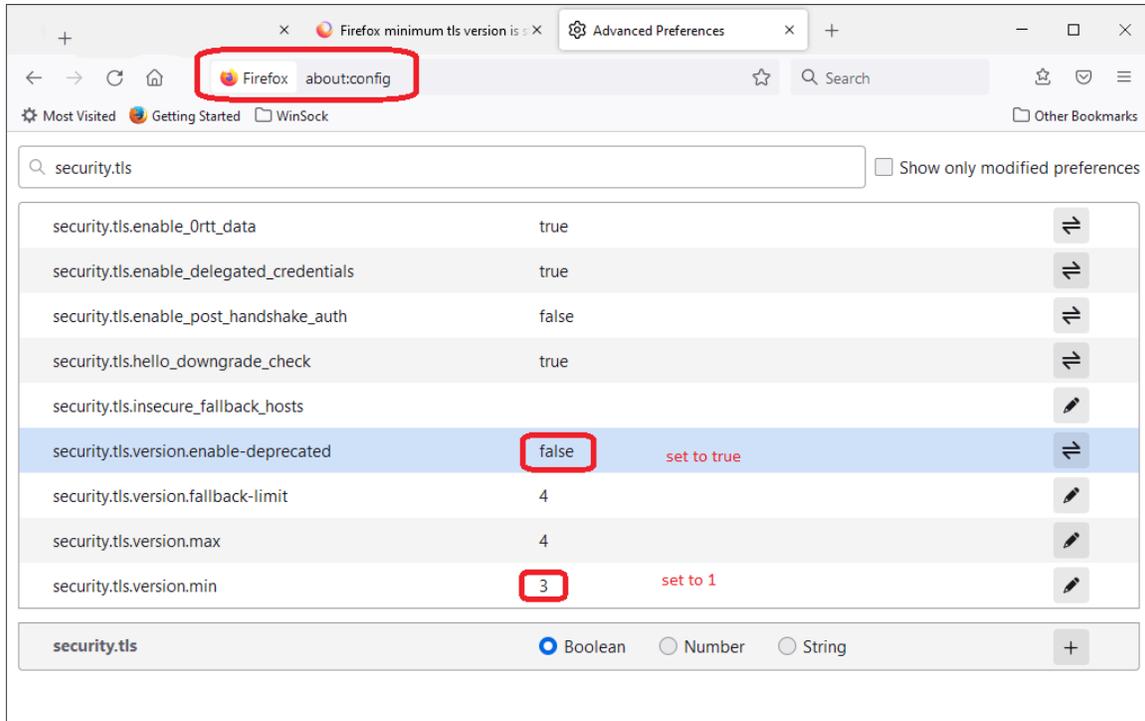
Firefox:
Within the Firefox browser, make the following changes to the about:config section:

This should let you connect. After you upgrade the firmware, it is recommended to repeat the above process and disable TLS 1.0 and 1.1.
